TL  
242  
.E6546  
1989

U.S. Department  
of Transportation  
**National Highway  
Traffic Safety  
Administration**

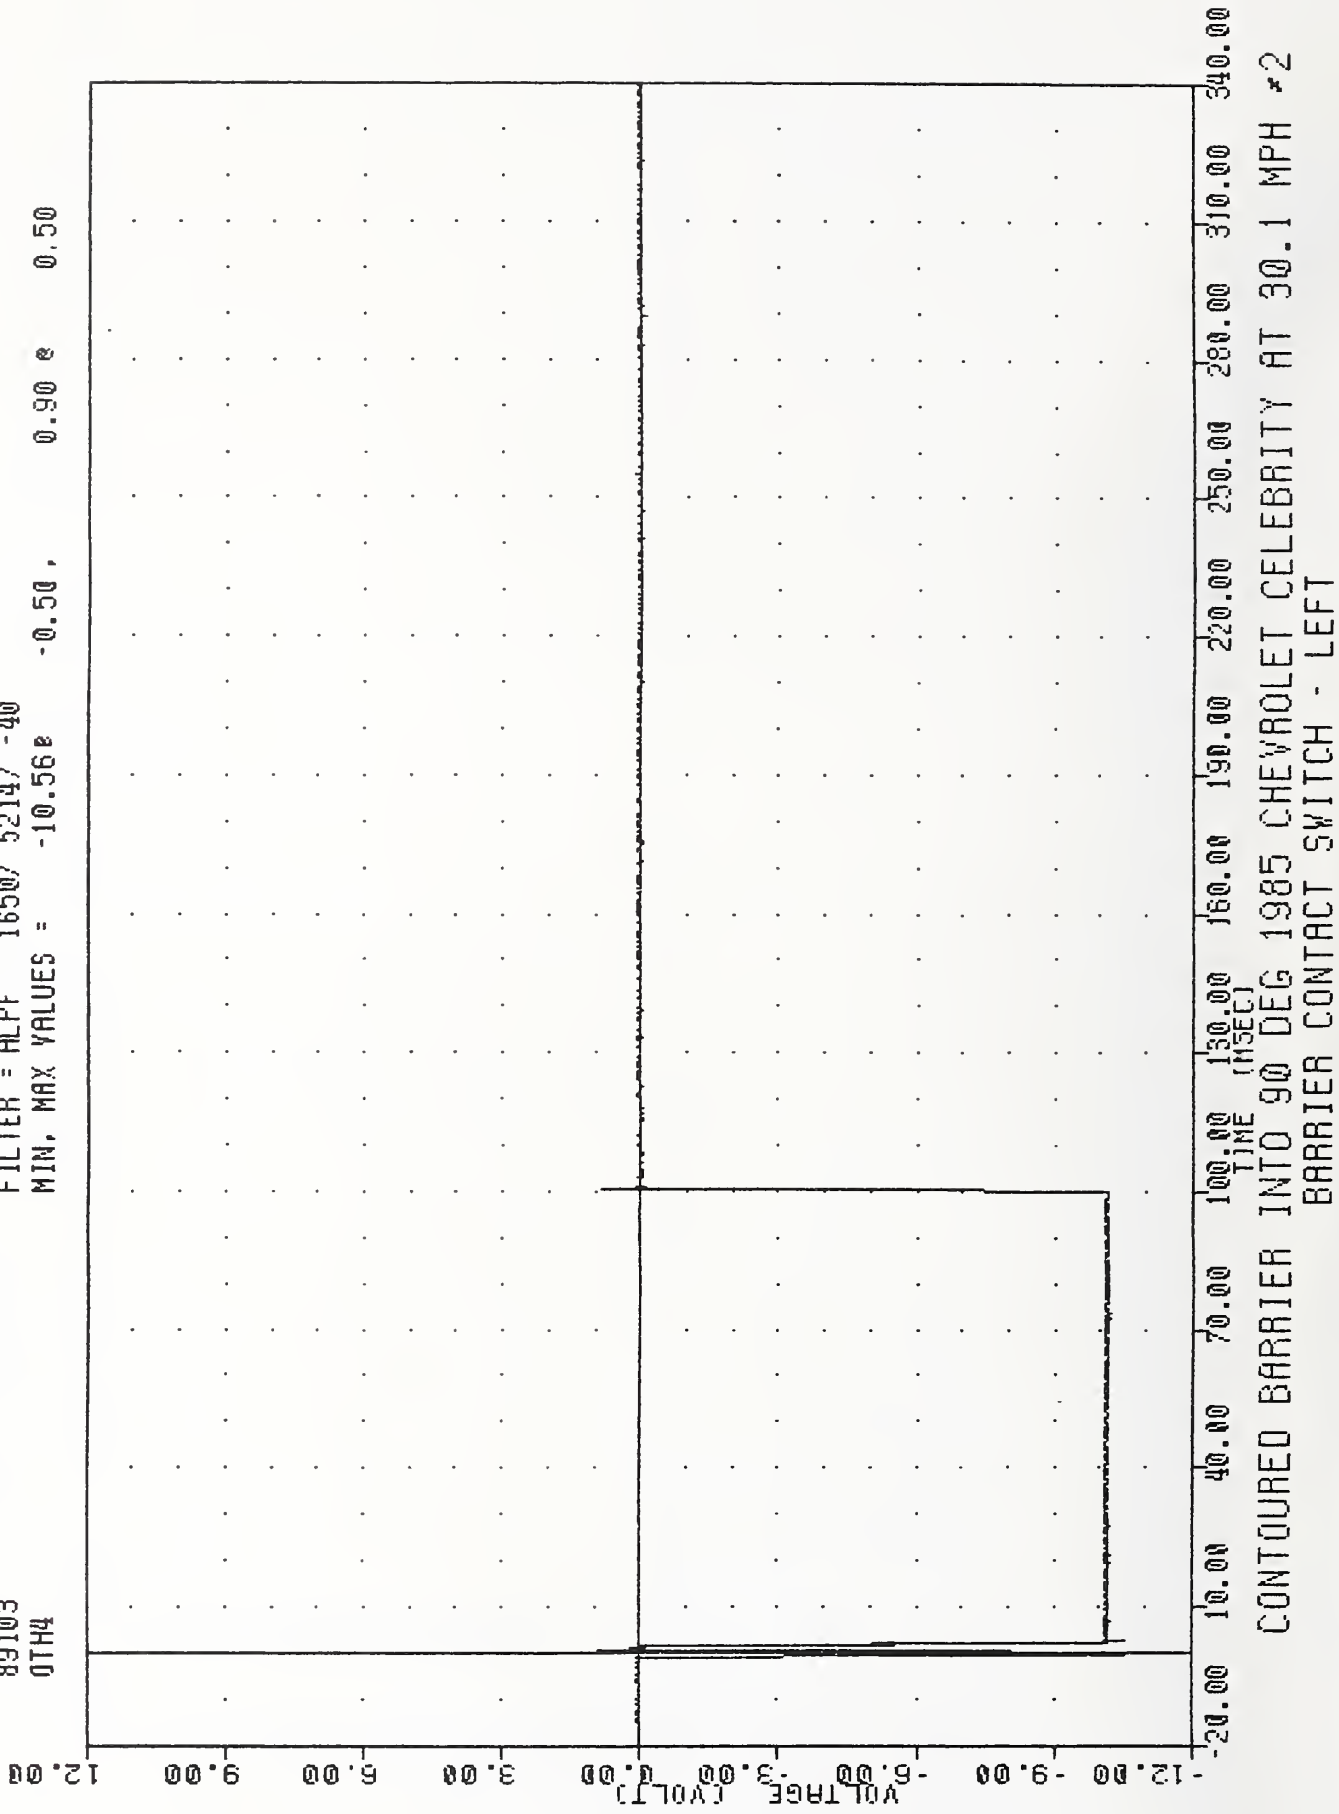
FILTER = ALPF 1650/ 5214/ -40  
MIN. MAX VALUES = -10.560 -0.50 , 0.90 0.50

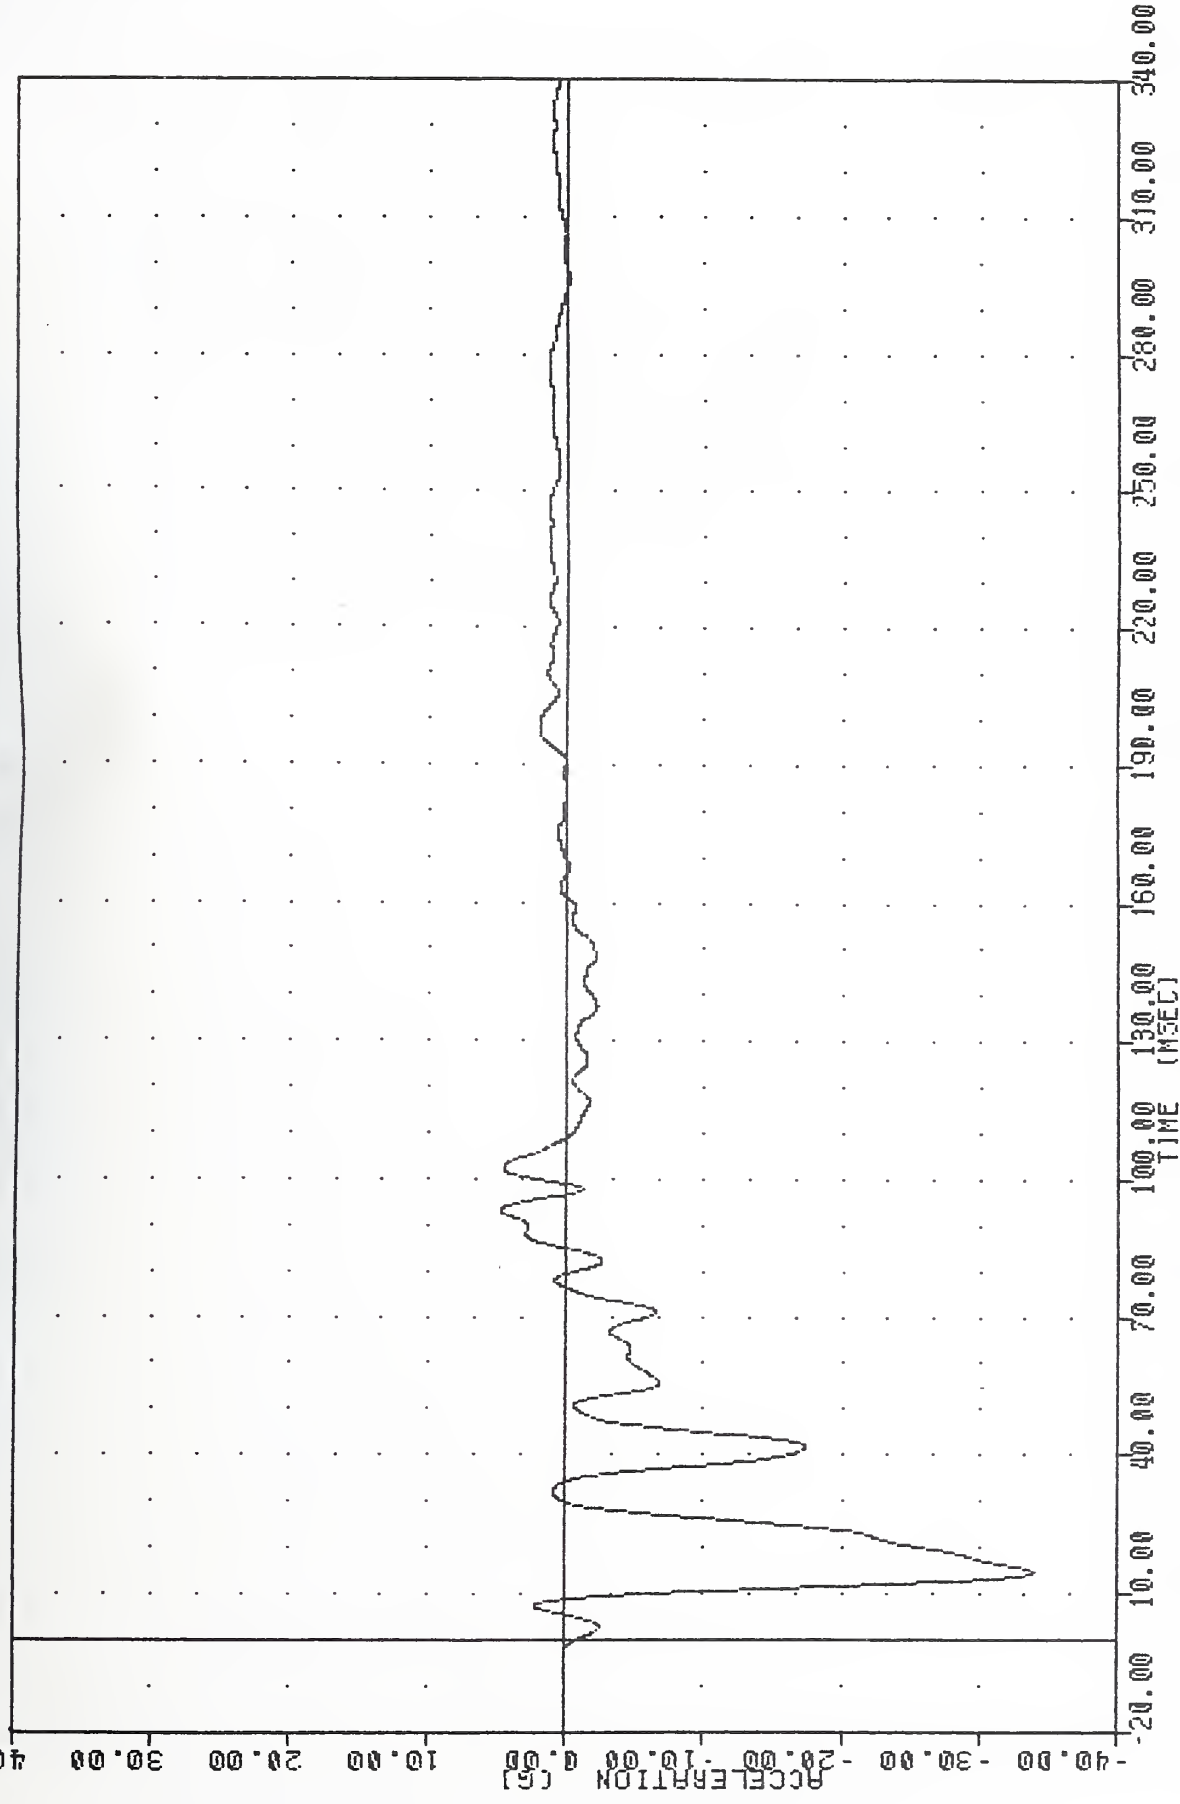
CONTOURED BARRIER INTO 90 DEG 1985 CHEVROLET CELEBRITY AT 30.3 MPH #3  
VEHICLE RIGHT FRONT SILL Y AXIS ACCELERATION

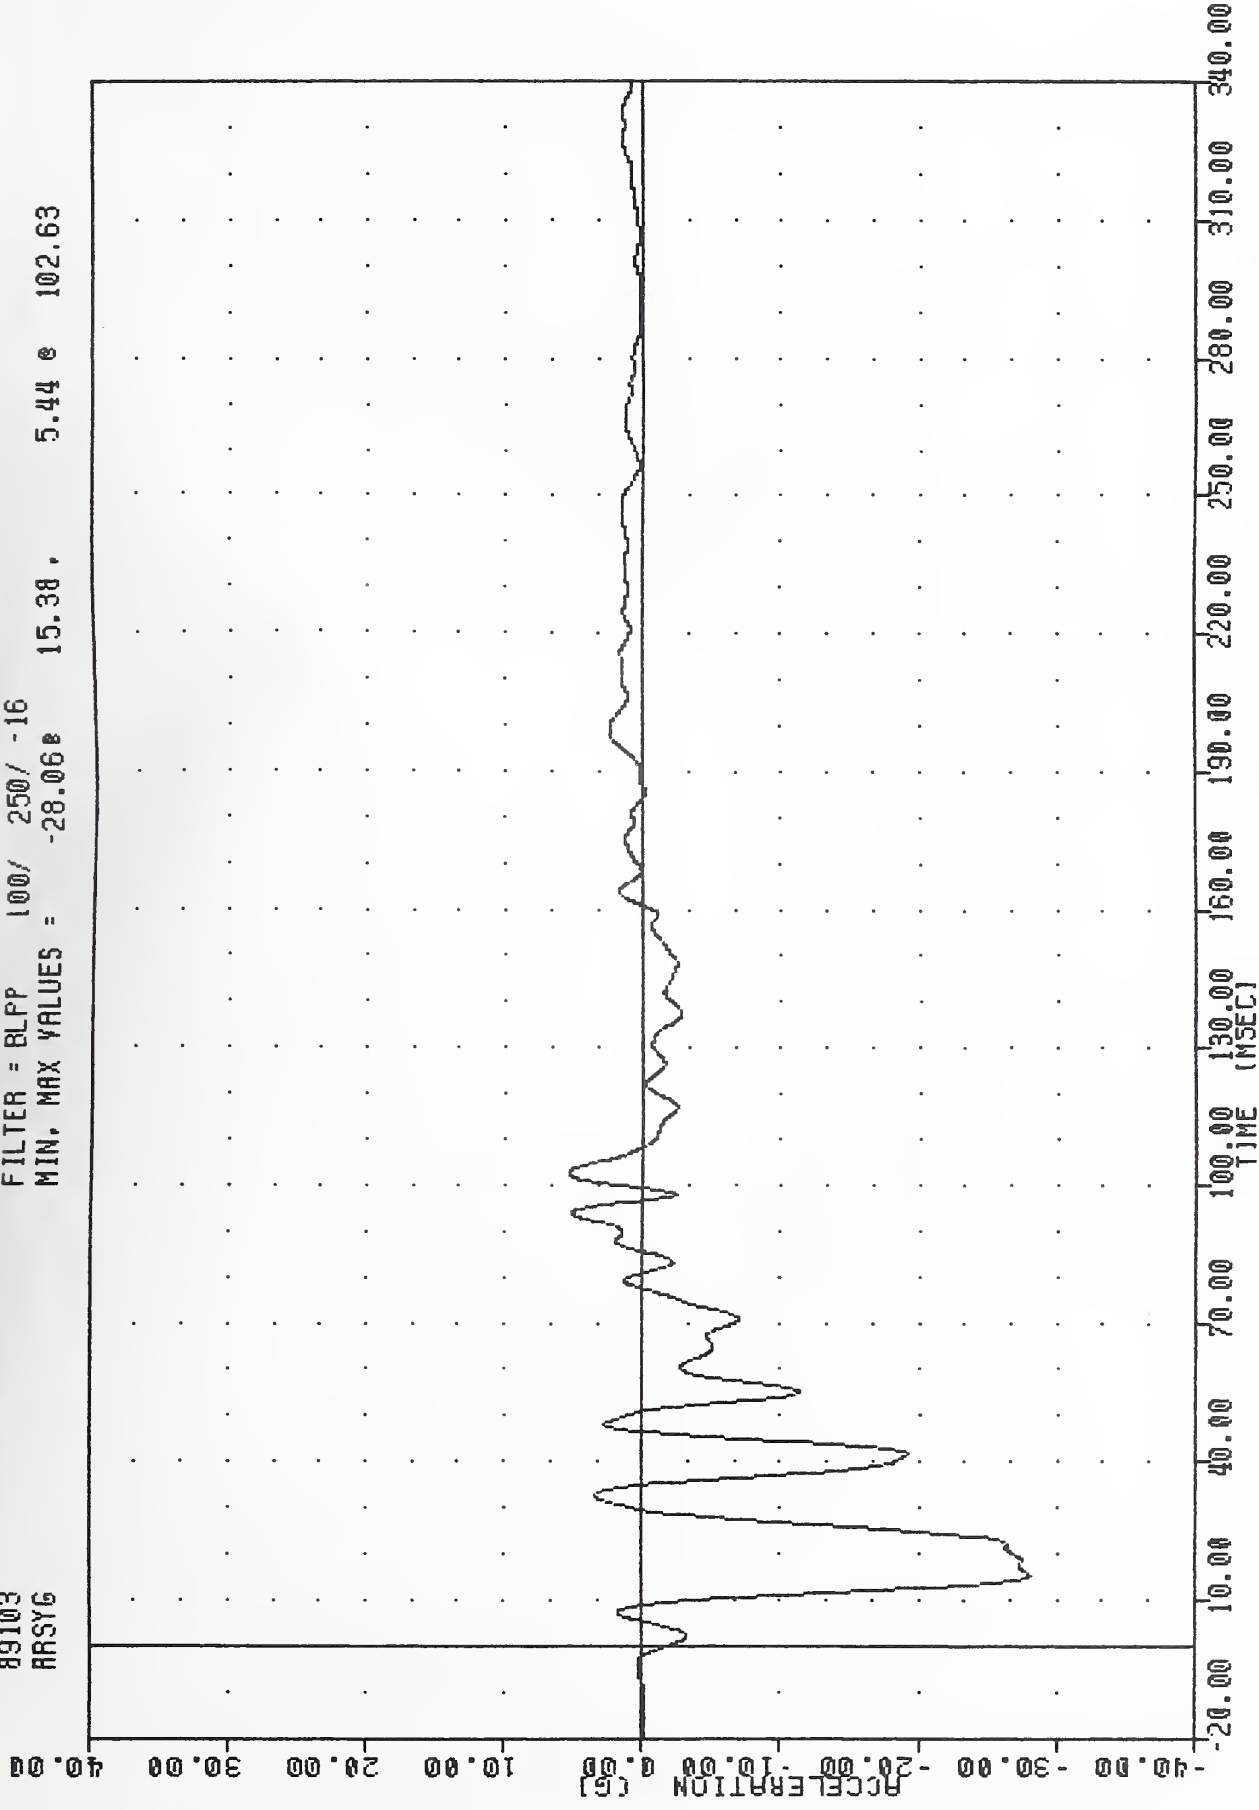
CONTOURED BARRIER INTO 90 DEG 1985 CHEVROLET CELEBRITY AT 30.3 MPH #3  
VEHICLE RIGHT REAR SILL Y AXIS ACCELERATION

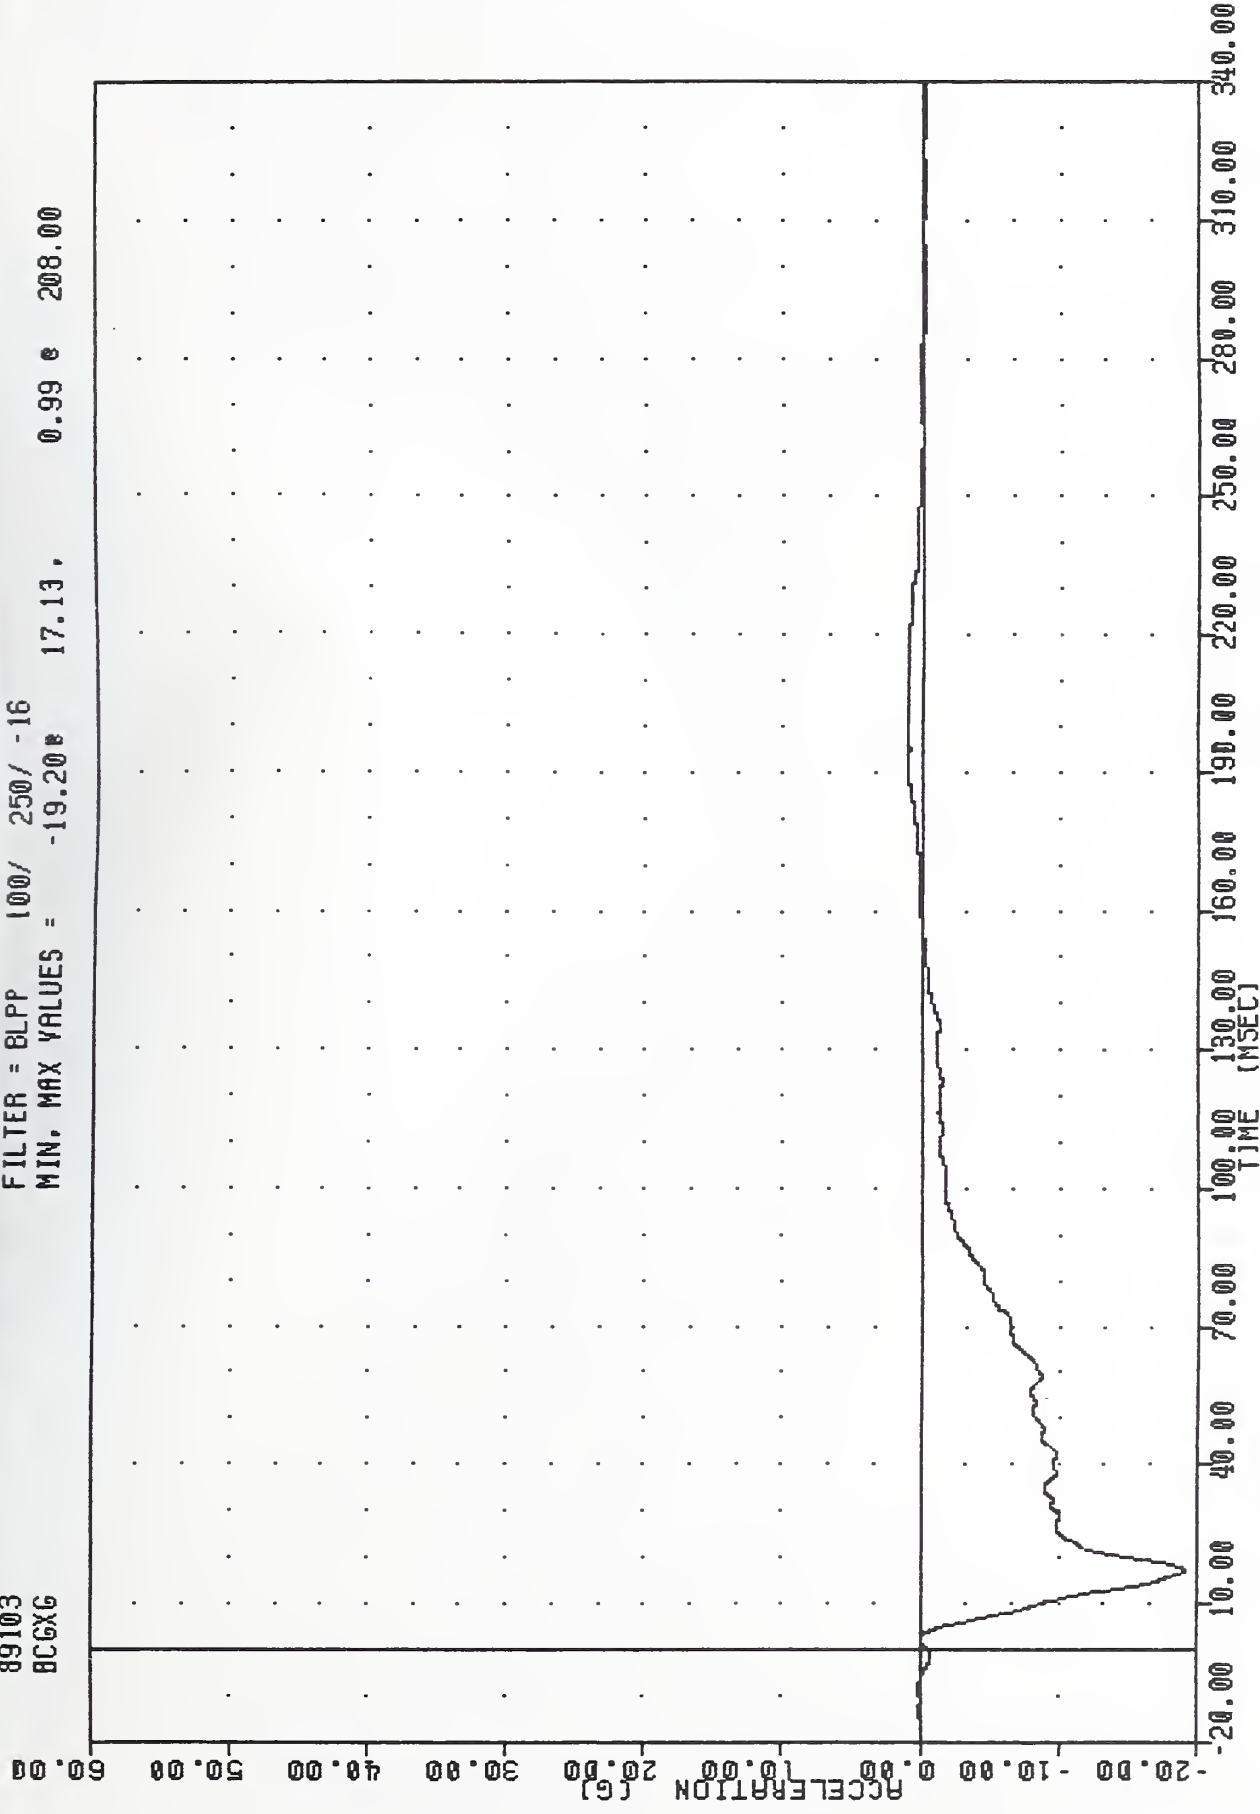
CONTOURED BARRIER INTO 90 DEG 1985 CHEVROLET CELEBRITY AT 30.3 MPH #3  
CONTOURED MOVING BARRIER CENTER OF GRAVITY X AXIS ACCELERATION

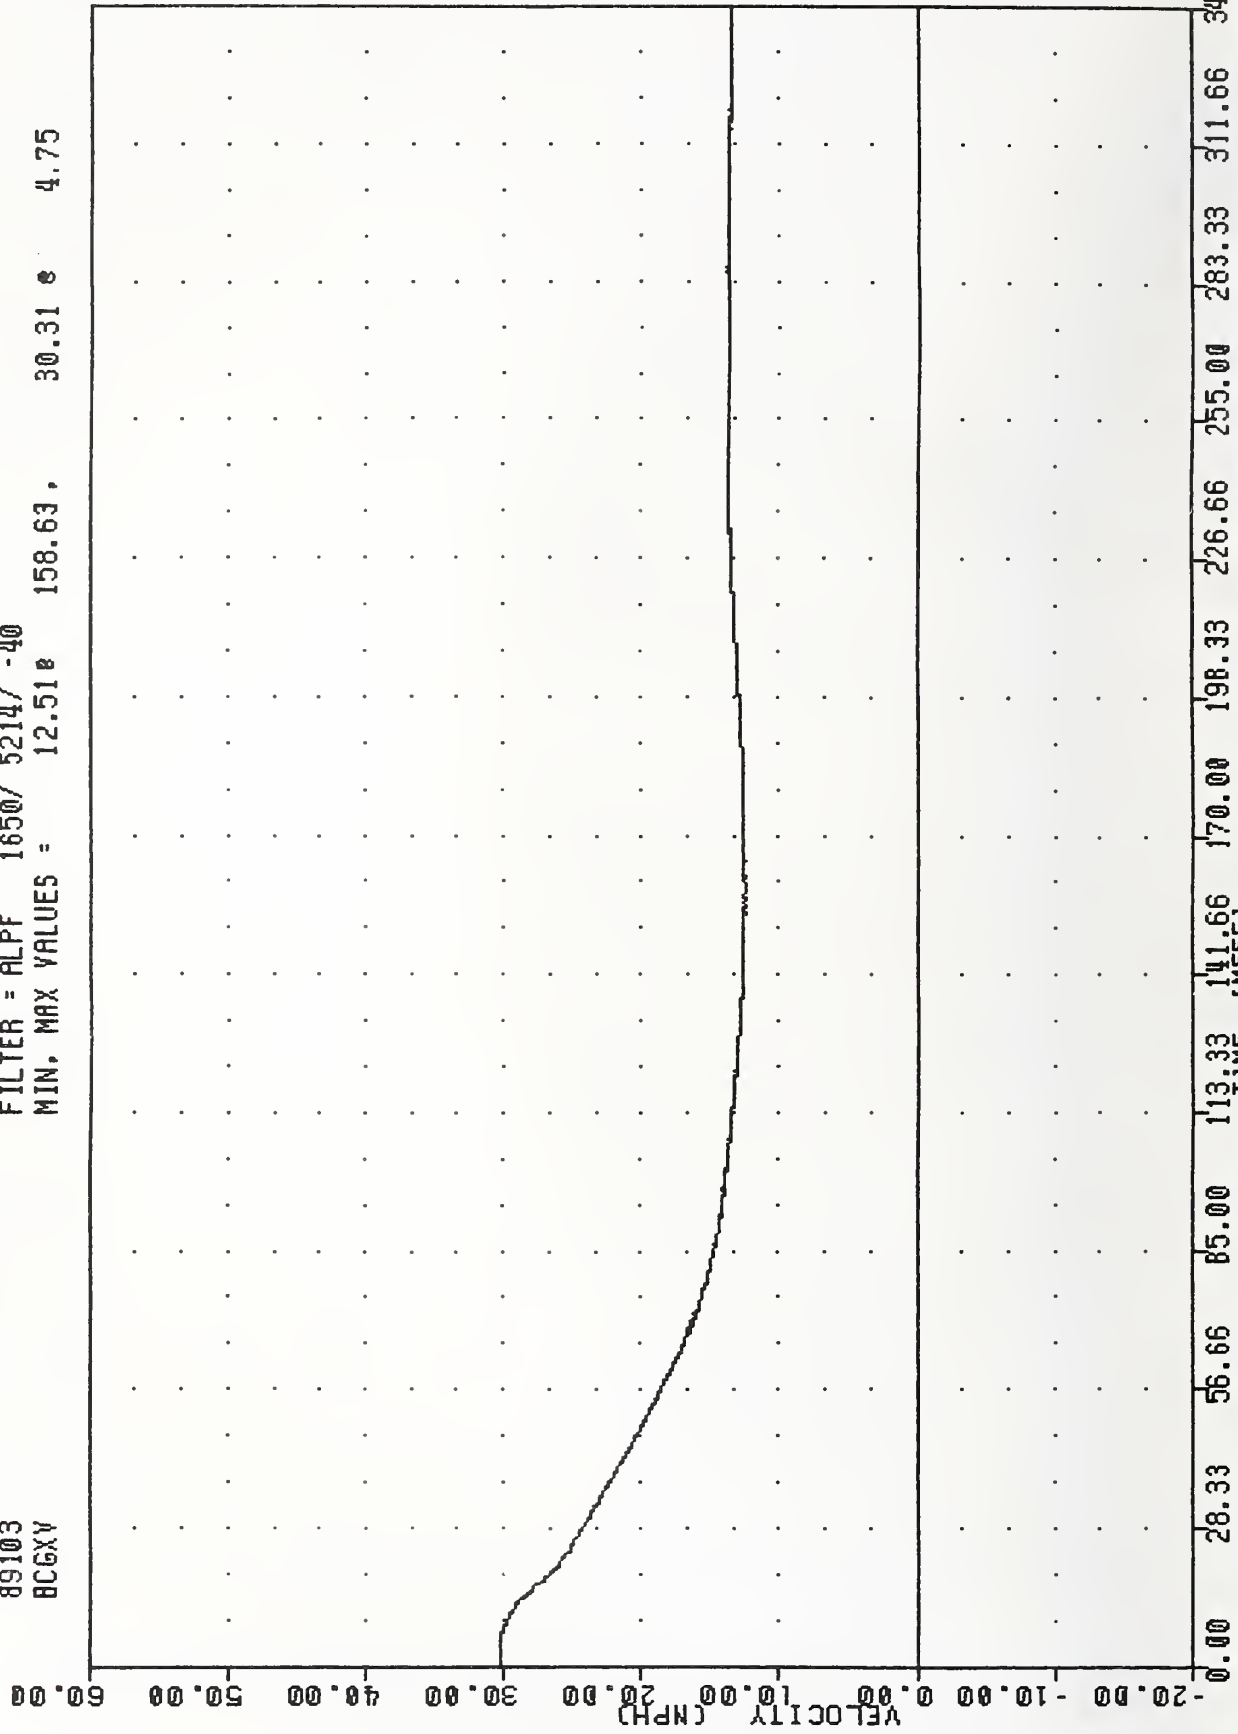
CONTOURED BARRIER INTO 90 DEG 1985 CHEVRON FT CELEBRITY AT 20 A NEW A  
 COUNTY WITH UP BARRIER X BYTES VELOCITY

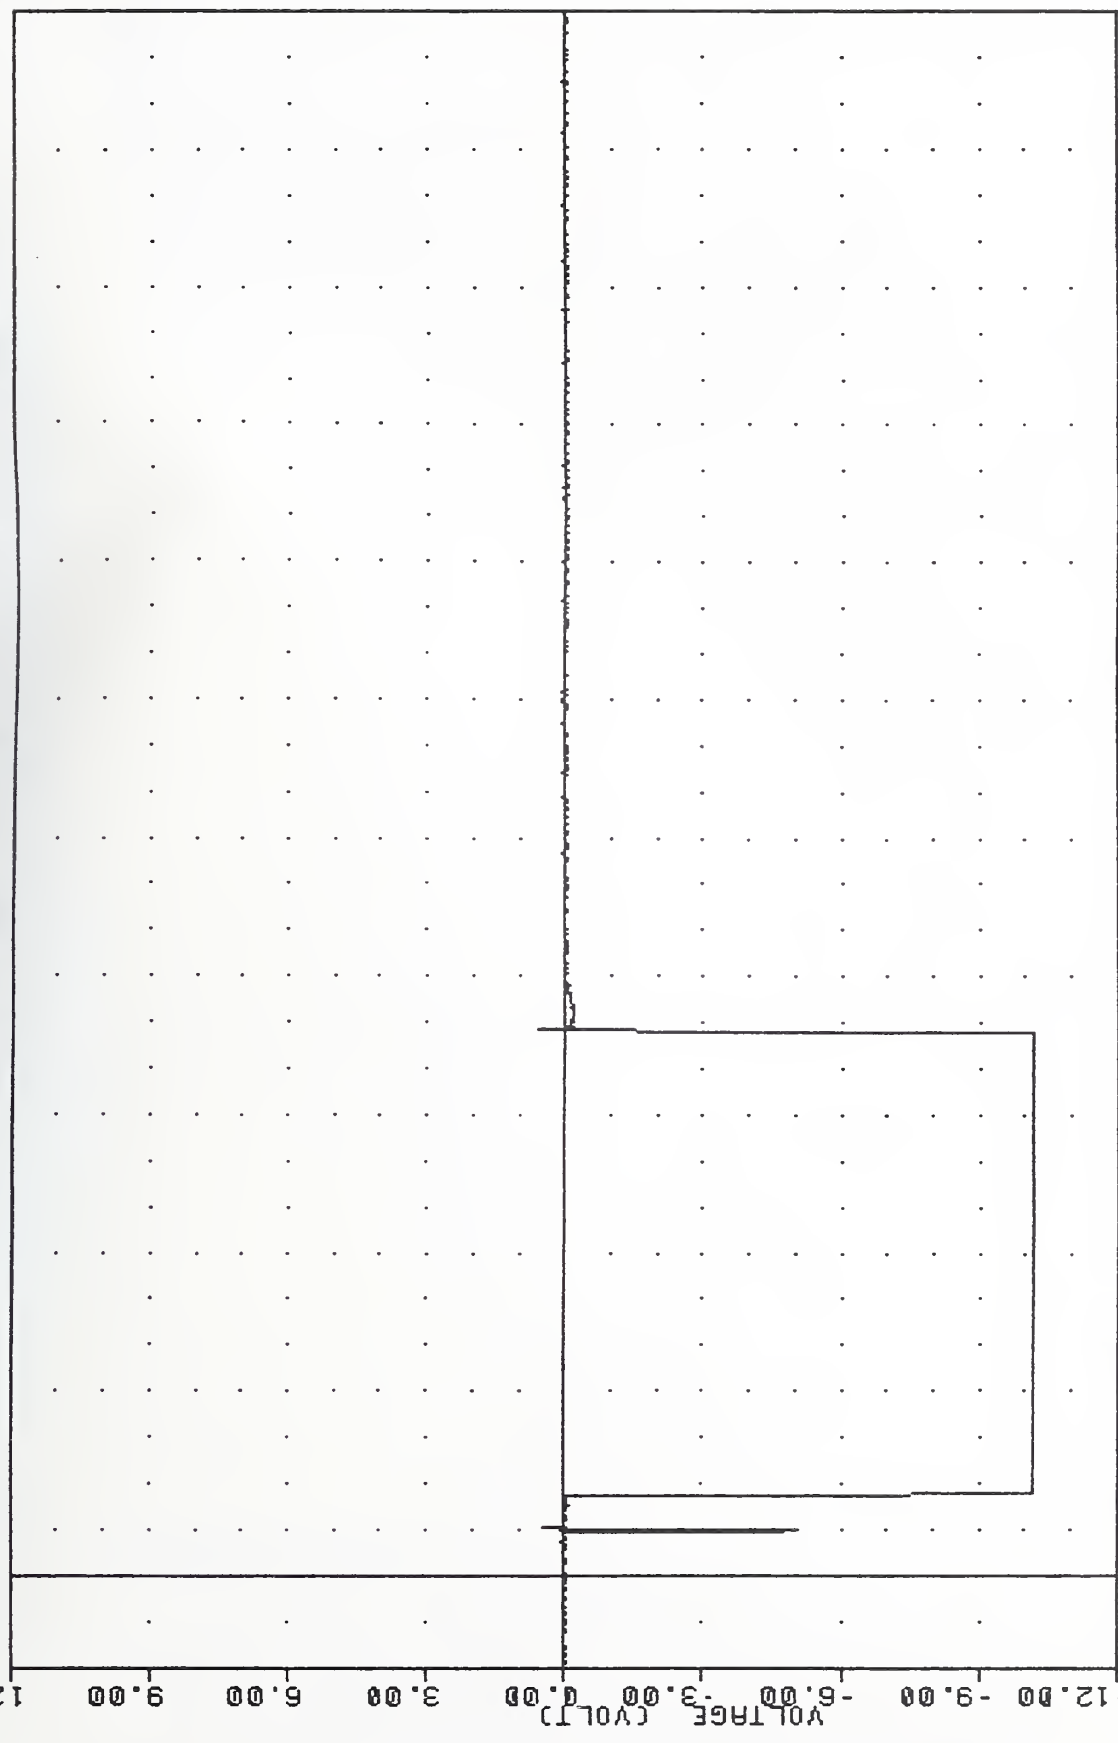
CONToured BARRIER INTO 90 DEG 1985 CHEVROLET CELEBRITY AT 30.3 MPH #3  
VEHICLE CONTACT SWITCH - FRONT

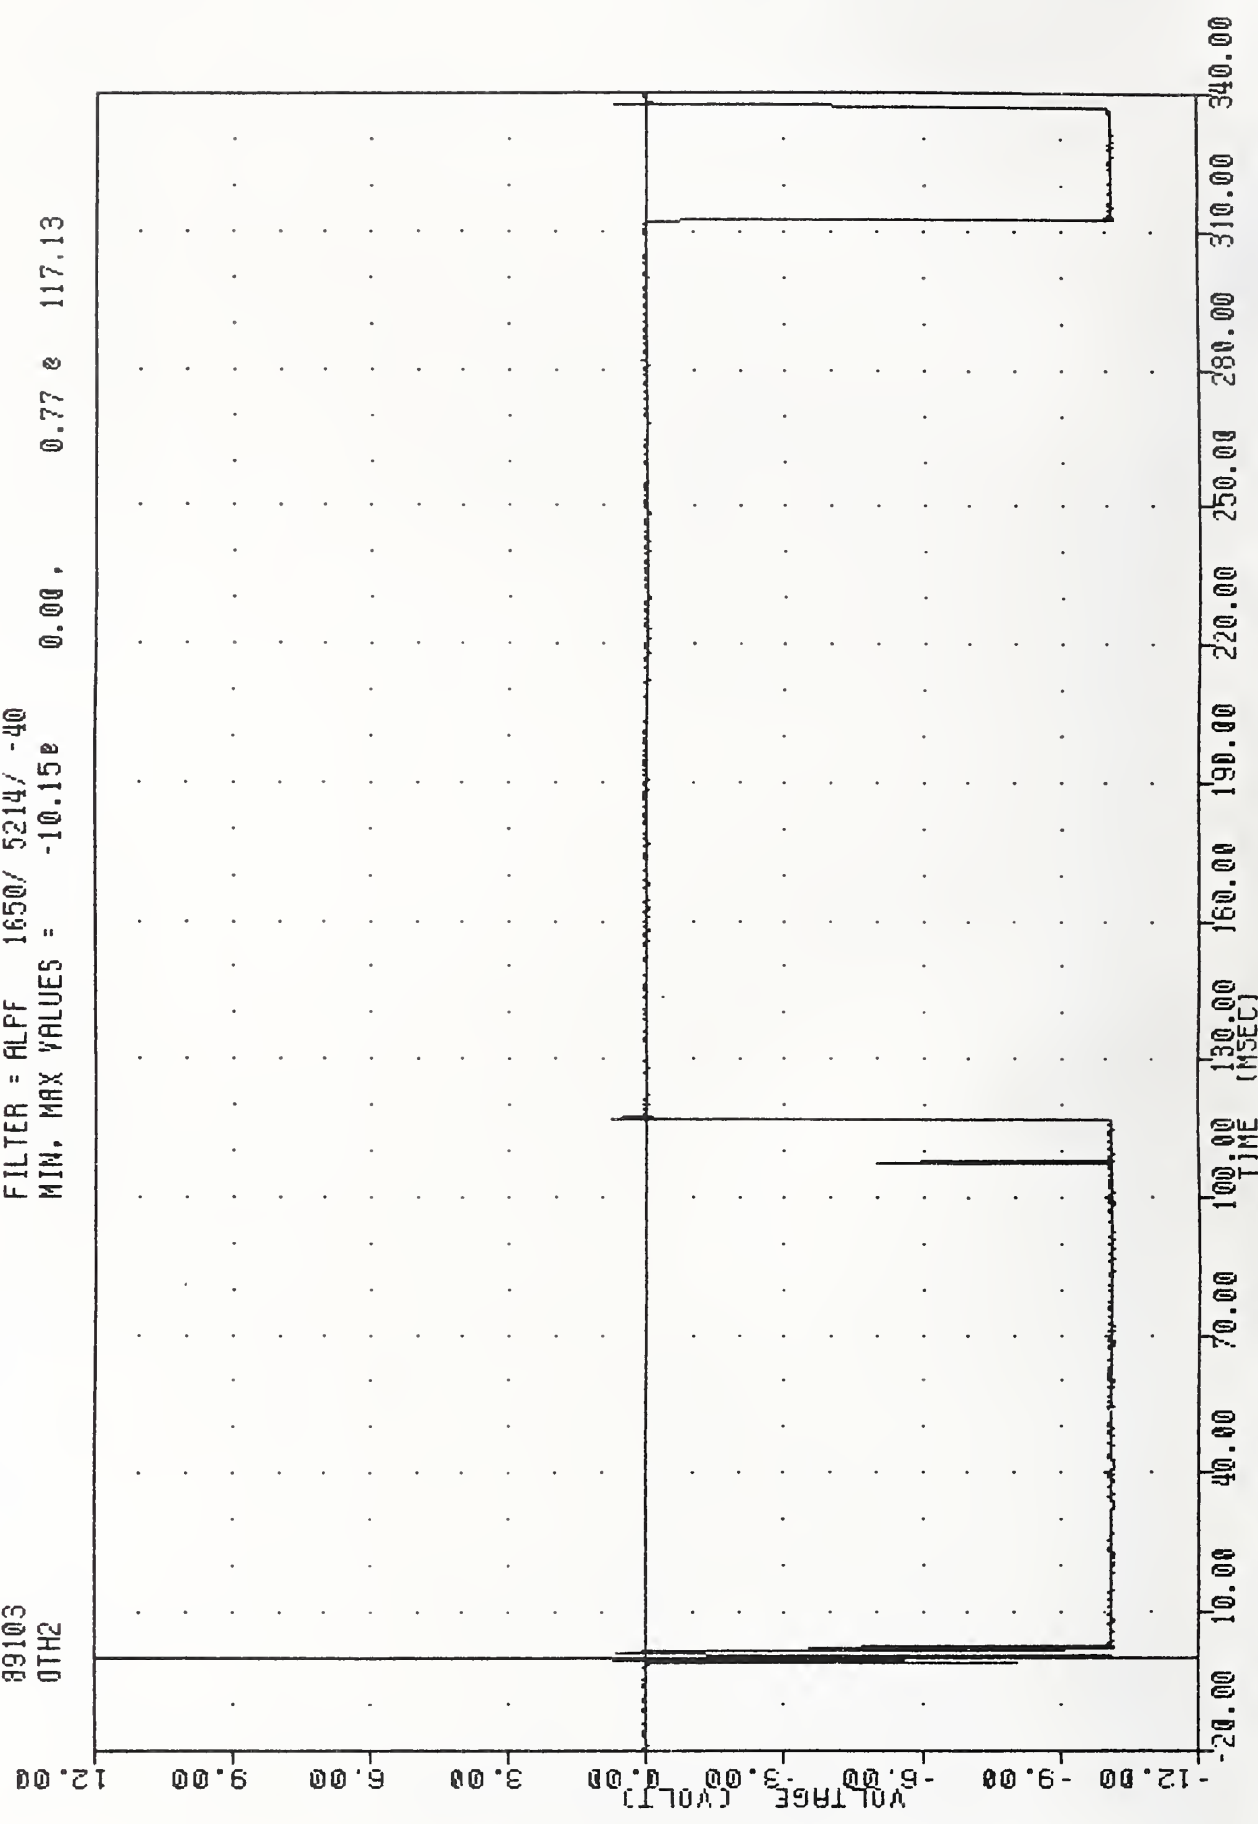
CONToured BARRIER INTO 90 DEG 1985 CHEVROLET CELEBRITY AT 30.3 MPH #3  
 VEHICLE CONTACT SWITCH - REAR

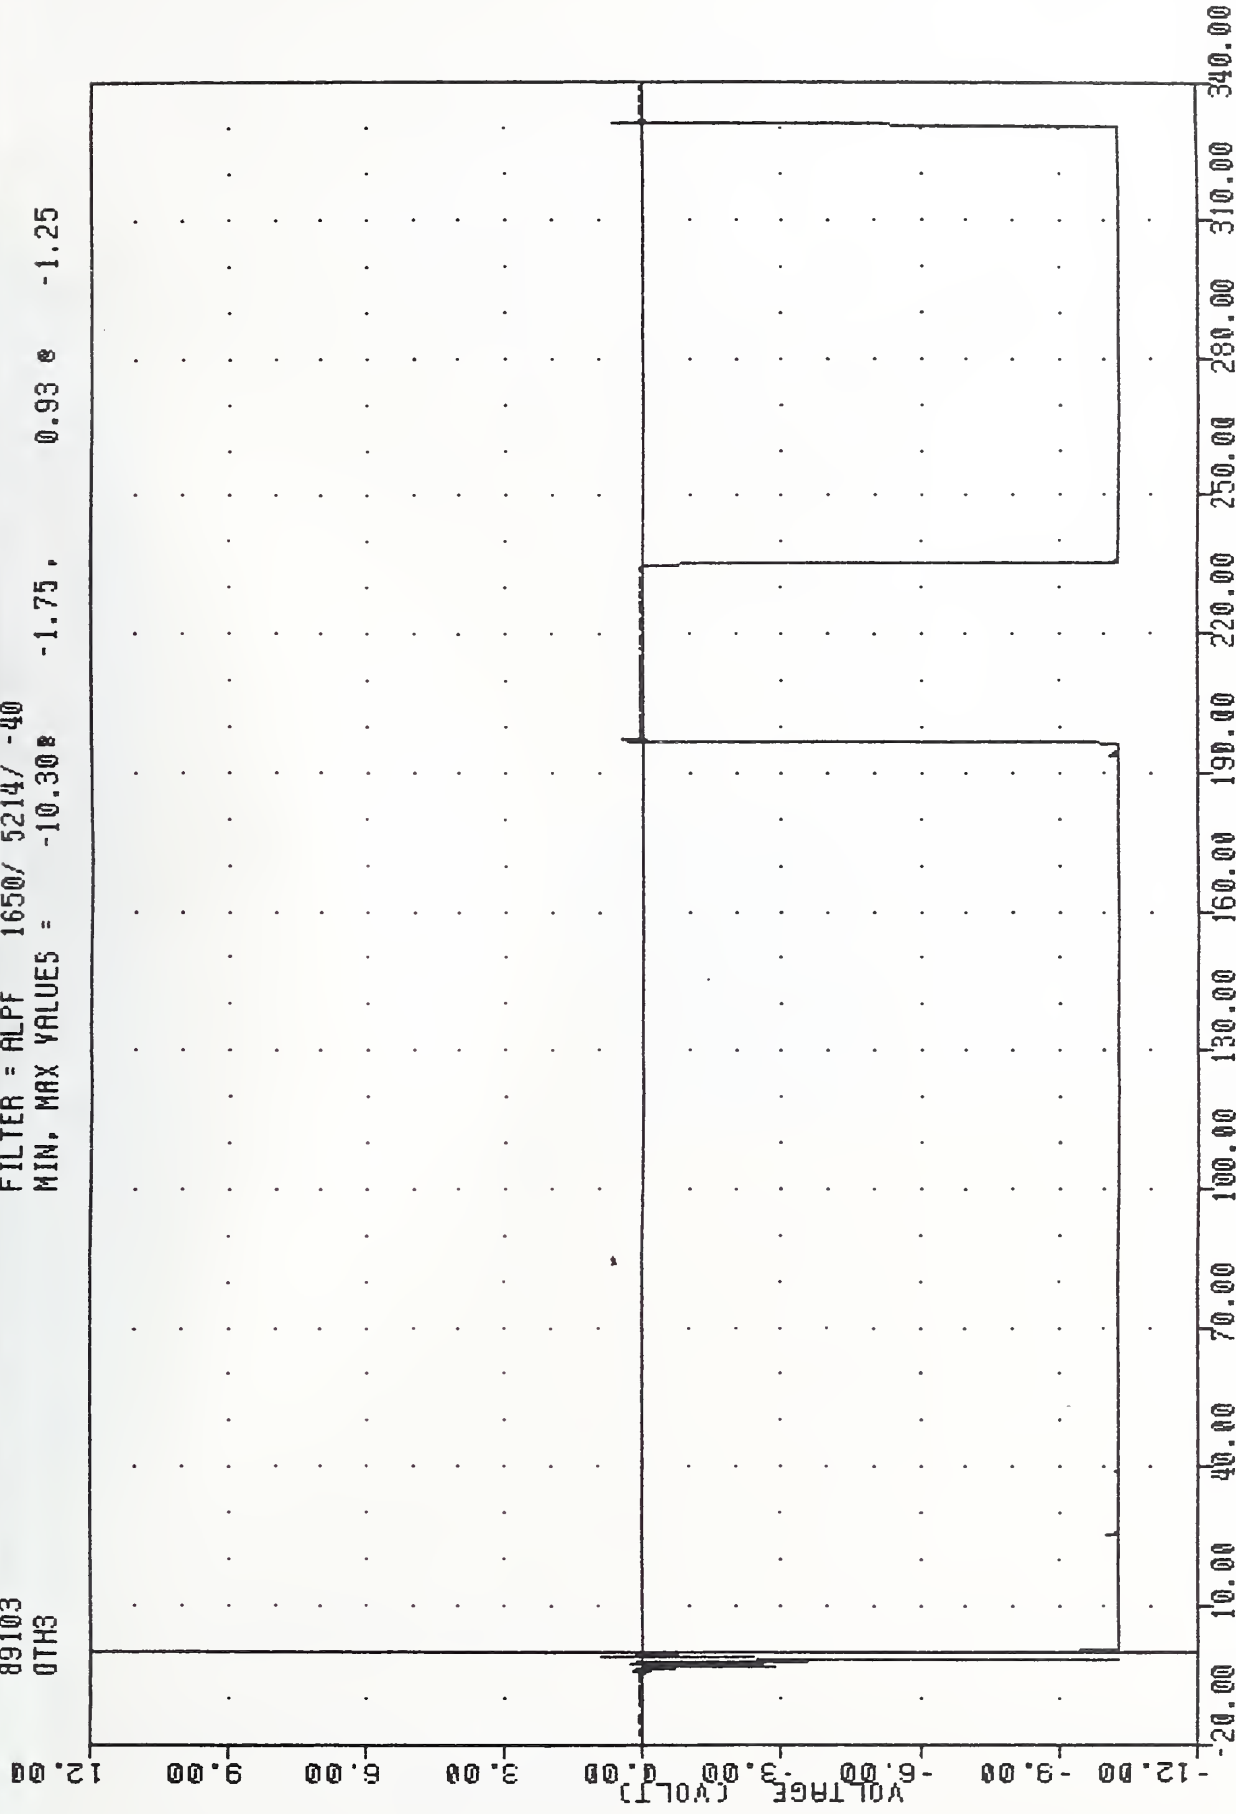
CONTOURED BARRIER INTO 90 DEG 1985 CHEVROLET CELEBRITY AT 30.3 MPH #3  
BARRIER CONTACT SWITCH - RIGHT
